Manhole Inspection Summary

Manhole # S27K__018MH

Insp Date: **6/16/08 7:56 AM**

Location Address: **1101 James st**

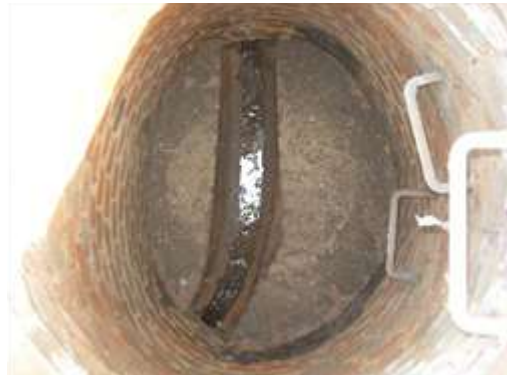
Top View

Condition: ☐ Sound ☐ Cracked ☐ Root Intrusion ☐ Loose Brick ☒ **Deteriorated**

Infiltration: ☐ None ☐ Joint ☐ Cracks ☒ **Mortar** ☐ Roots ☐ Wall
